# New Hampshire Volunteer Lake Assessment Program

## 2003 Interim Report for Loon Pond Gilmanton

NHDES  
Water Division  
Watershed Management Bureau  
29 Hazen Drive  
Concord, NH 03301

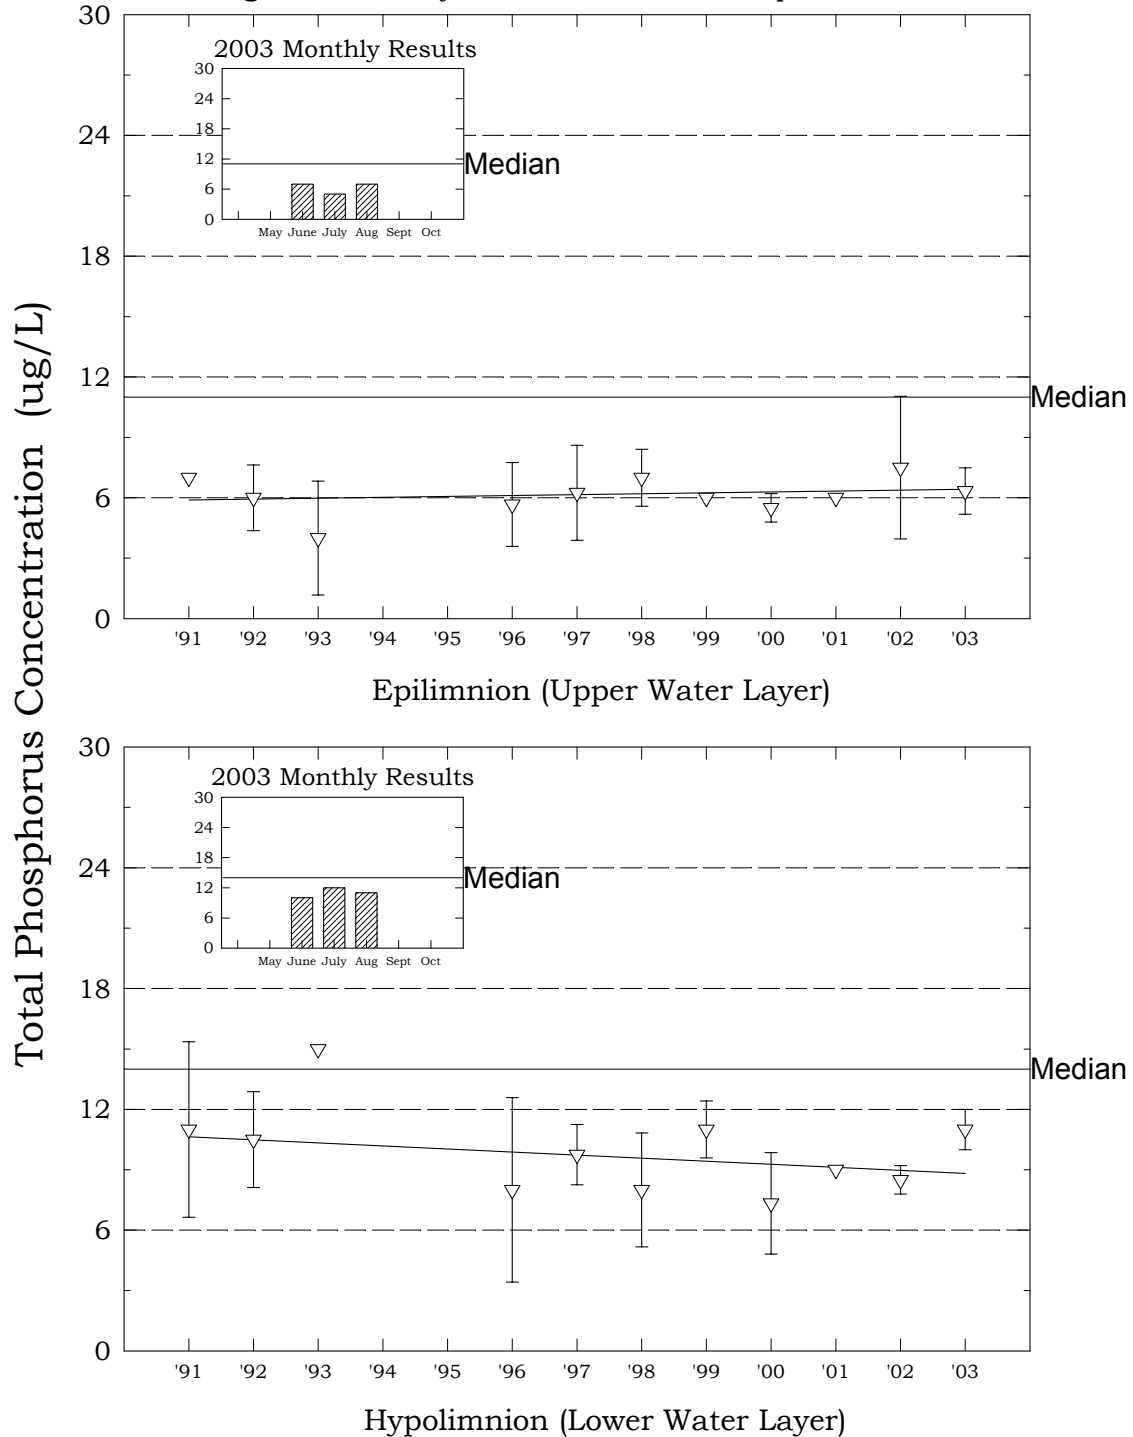
**Figure 3.** Monthly and Historical Total Phosphorus Data.

- **Figure 3 and Table 8:** The graphs in Figure 3 (Appendix A) show the amounts of phosphorus in the epilimnion (the upper layer) and the hypolimnion (the lower layer); the inset graphs show current year data. Table 8 (Appendix B) lists the annual maximum, minimum, and median concentration for each deep spot layer and each tributary since the lake/pond has joined the program.

The current year data for the epilimnion (the top inset graph) show that the phosphorus concentration ***decreased slightly*** from June to July, and then ***increased slightly*** from July to August. The phosphorus concentration on each sampling event was ***much less than*** the state median.

The current year data for the hypolimnion (the bottom inset graph) show that the phosphorus concentration ***increased slightly*** from June to July, and then ***decreased slightly*** from July to August. The phosphorus concentration on each sampling event was ***less than*** the state median.

Overall, visual inspection of the historical data trend line for the epilimnion shows a ***relatively stable*** total phosphorus trend. Specifically, the phosphorus concentration in the epilimnion has ***remained approximately the same*** (and ***much less than*** the state median) since monitoring began.

Overall, visual inspection of the historical data trend line for the hypolimnion shows a ***slightly decreasing*** total phosphorus trend, which means that the concentration has ***slightly improved*** since monitoring began. We hope this trend continues!
